Radiance Simulations Suffield Academy Athletic Center

Suffield Academy Athletic Center Radiance Simulations

Name of Project: Suffield Academy Athletic Center

Name of Daylighting Technology: Solera®

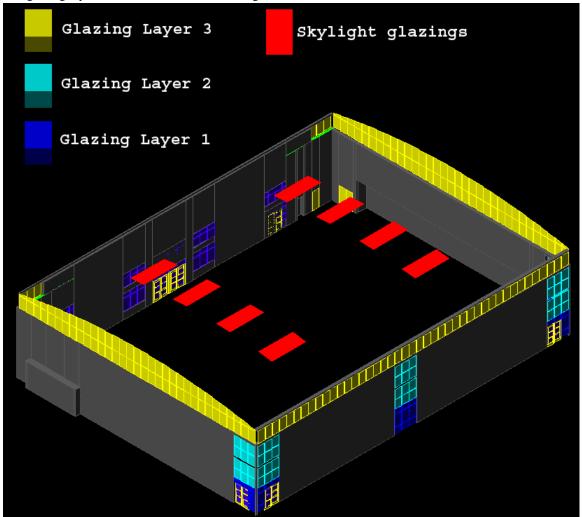
Figure 1 The glazing layers that define the various configurations rendered.

Three different glazing configurations were rendered for the gymnasium. Configuration 1 uses vision glass for all the glazing layers and the skylights. Configuration 2 uses vision glass for glazing layer 1, Solera with a 33% visible light transmittance (VLT) for glazing layer 3, Solera with a 26% VLT for glazing layer 2, vision glass for glazing layer 1, and Solera with a 50% VLT for the skylights. Configuration 3 is the same as Configuration 2 except the vision glass in glazing layer 1 was replaced with Solera with a 26% VLT. Figure 1 shows the various glazing layers.

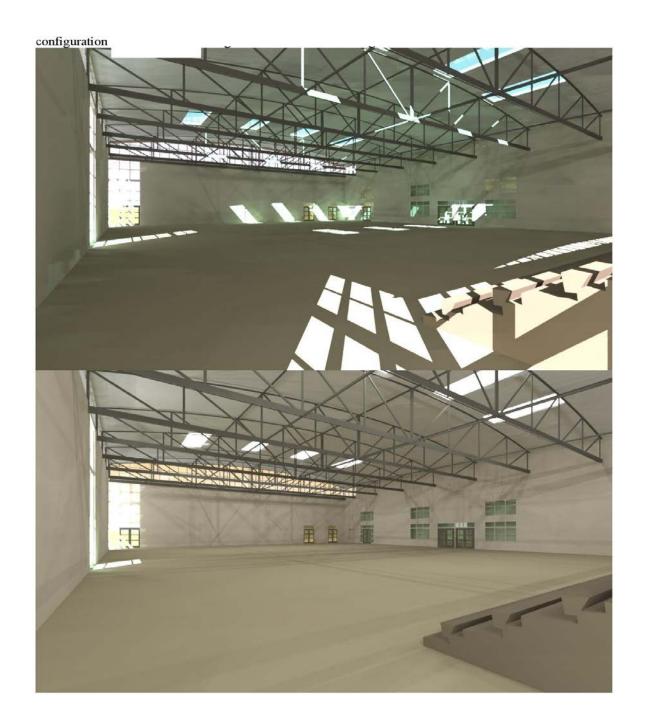
Figure 2 Two images of the gymnasium rendered at 2pm on March 21. The top image was rendered with configuration 1 and the bottom was rendered with configuration 2.

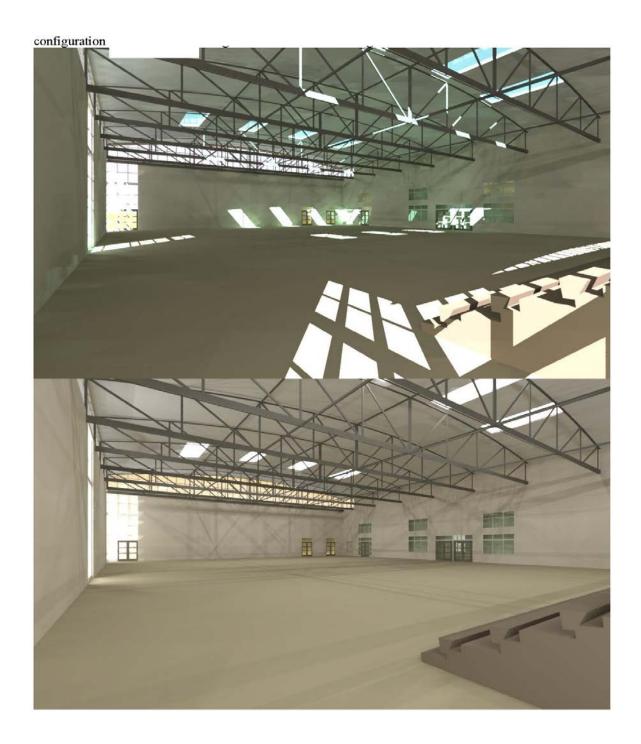
Figure 3 Two images of the gymnasium rendered at 2pm on March 21. The top image was rendered with configuration 1 and the bottom with configuration was rendered with configuration 3.

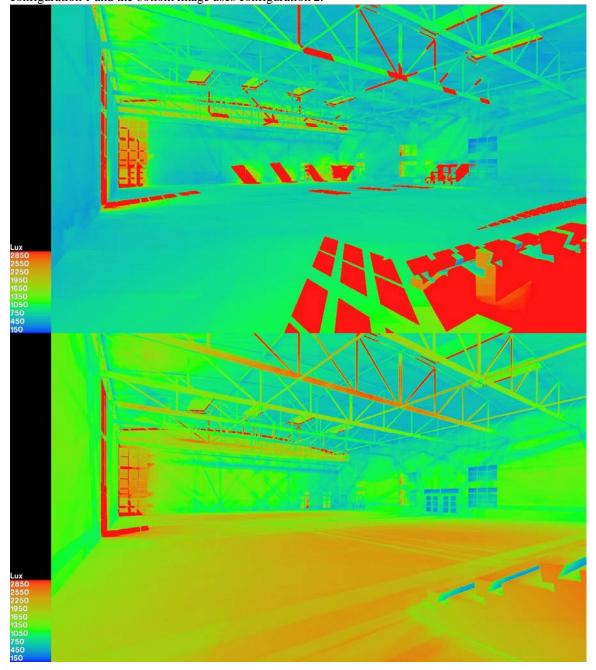
Figure 4
Two false colored illuminace images of the gymnasium rendered at 2pm on March 21. The top image uses configuration 1 and the bottom image uses configuration 2.

Figures 4 and 5 are false colored illuminance images showing the intensity of incident light on the surfaces within the space. The intensity is measured in Lux and the color scale mapping the color values to Lux values may be found on the lower left hand corner of each image. When studying the images, keep in mind that anything appearing red is at or above the maximum value of the scale. For example, the glare patches in configuration 1 as seen in Figure 4 appear red indicating that they are greater than or equal to the maximum value in the color scale. The scale used for the image has a maximum of 3000 Lux, but the actual Lux value of the red patches is around 22000 Lux. Also note that different scales are used for different sets of pictures so be sure to look at the scale in each set of pictures.

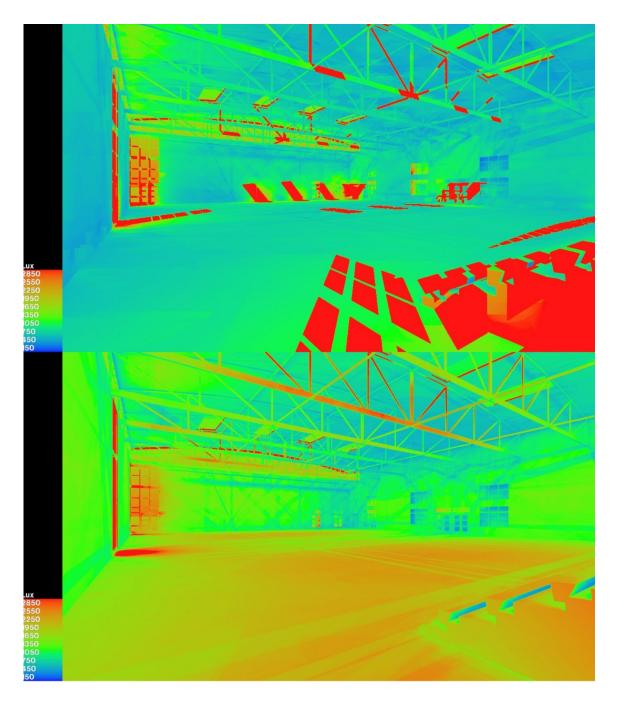
Figure 5 Two false colored illuminace images of the gymnasium rendered at 2pm on March 21. The top image uses configuration 1 and the bottom configuration 3.

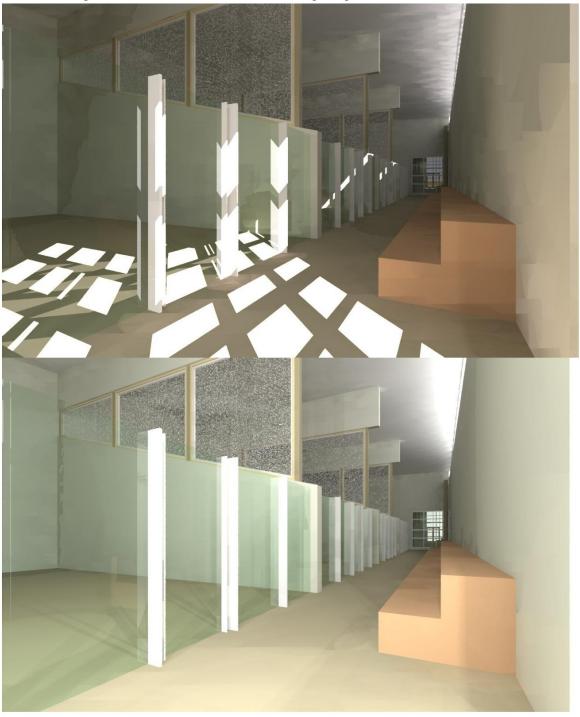
Figure 6 The squash courts rendered at 2pm on March 21. The top image uses vision glass for all the glazings and the bottom image uses Solera with a 26% VLT for all the glazings.

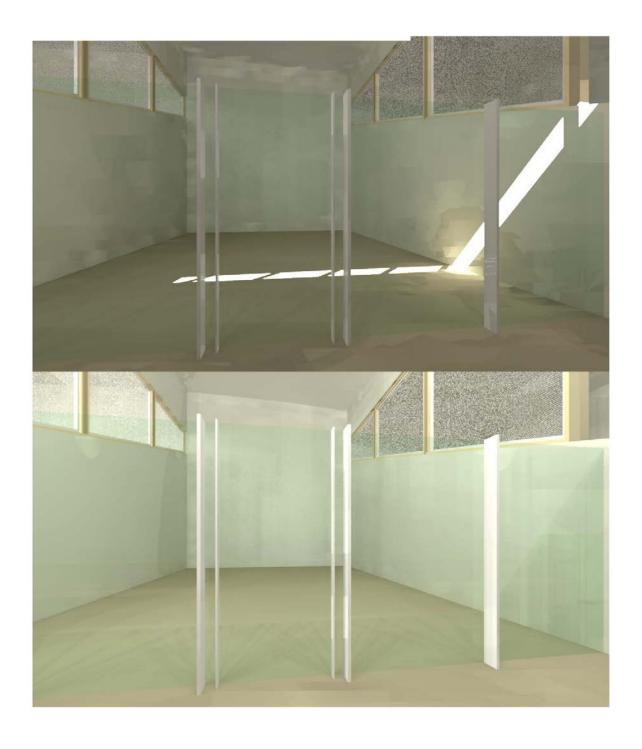
Figure 7
A squash court rendered at 2pm on March 21. The camera for these images was placed on the bench and looks into one of the middle squash courts. The top image uses vision glass for all the glazings and the bottom image uses Solera with a 26% VLT for all the glazings.

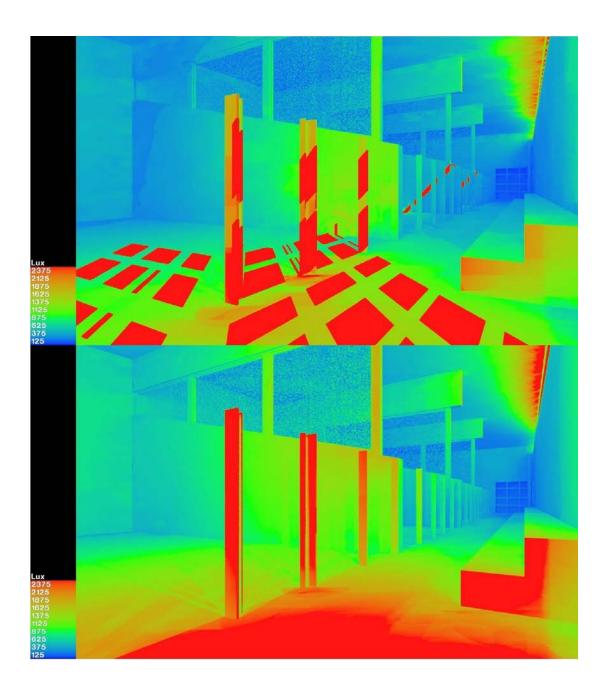
Figure 8 The squash courts rendered at 2pm on March 21 using false colors. The top image uses vision glass for all the glazings and the bottom image uses Solera with a 26% VLT for all the glazings.

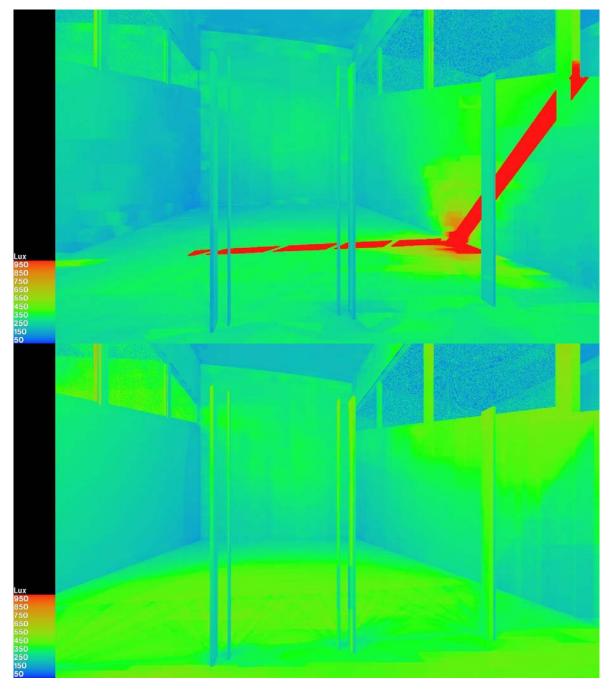
Figure 9 The squash court rendered at 2pm on March 21 using false colors. The top image uses vision glass for all the glazings and the bottom image uses Solera with a 26% VLT for all the glazings.
